COMPLETION REPORT

GLEN-VIEW CHOLERA INTERVENTION

Name of Project	Glen View Sanitation Project Report
Sector	Water and Sanitation
Allocated Funds	US\$146 ,443.99
Sponsor	Infrastructure Development Bank of Zimbabwe
Implementing Partners	Harare City Council (HCC)
Type of project	Rehabilitation and expansion of the town's existing water treatment and distribution infrastructure.
Objectives	Upgrading of Sewerage infrastructure to Glen View township, Harare.
Project Description and Components	<ul style="list-style-type: none"> Upgrading of burst out old water reticulation network replacement and rerouting of approximately 1200 metres by 250mm diameter non-functional sewer reticulation lines in Glenview
Location	Glen View, Harare

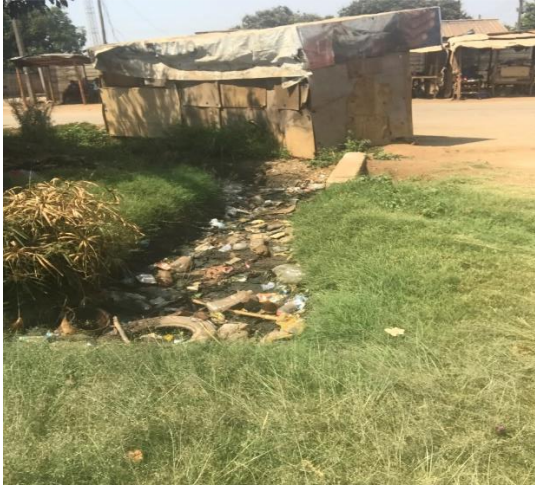
DRAIN FILLED WITH RAW

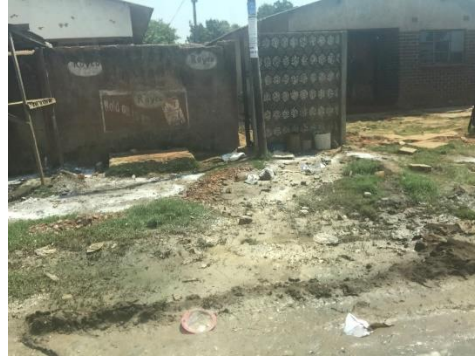
RAW SEWER FLOWING

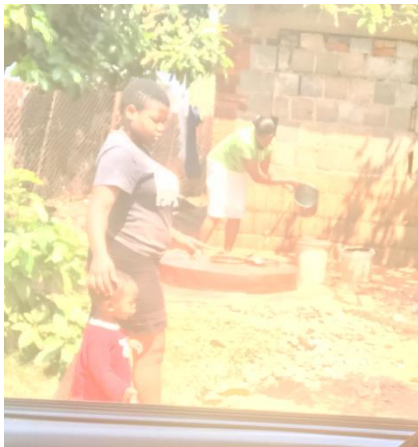
WOMAN FETCHING
WATER FROM A WELL
CLOSE TO RAW SEWER

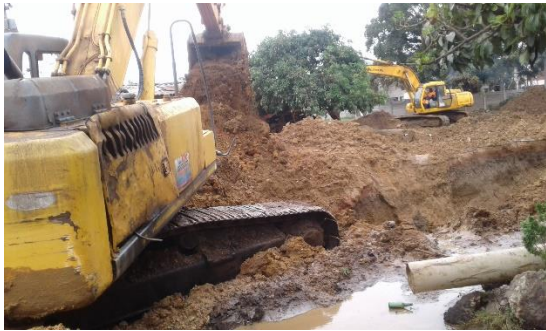
- The soil was unstable, and the groundwater table was high which made the working conditions unsafe and difficult in the deep trenches. The trenches were more often collapsing due to the bad soil mechanics of the area. Safety precautions had to be undertaken.

Dry Collapsible Material

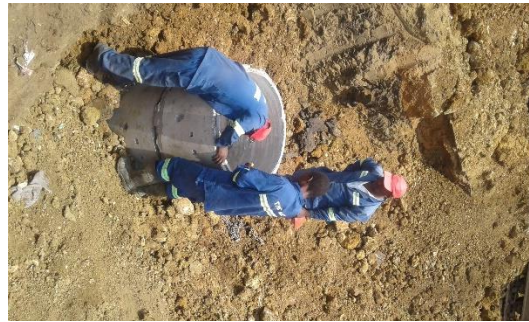
Manhole being set

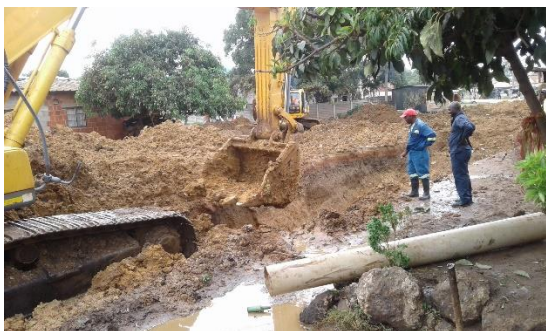
Removing collapsed material

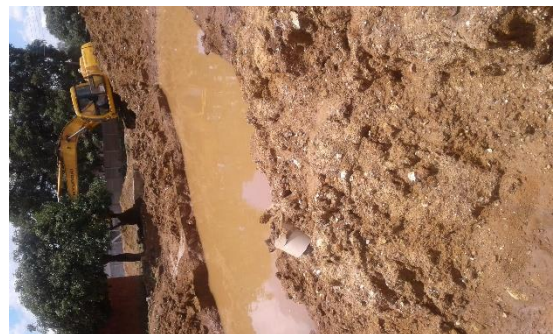
Ground water filled the trenches

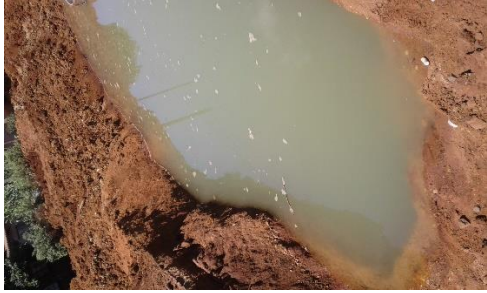
Ground water filled the trenches

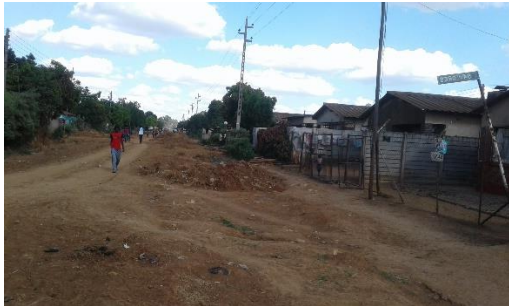
Road needs rehabilitation

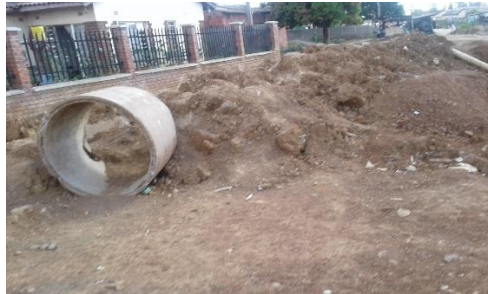
Road needs clearing and rehabilitation
